K-617

Hem-Mar Farm

Near Chesterville

Maryland Historical Trust State Historic Sites Inventory Form

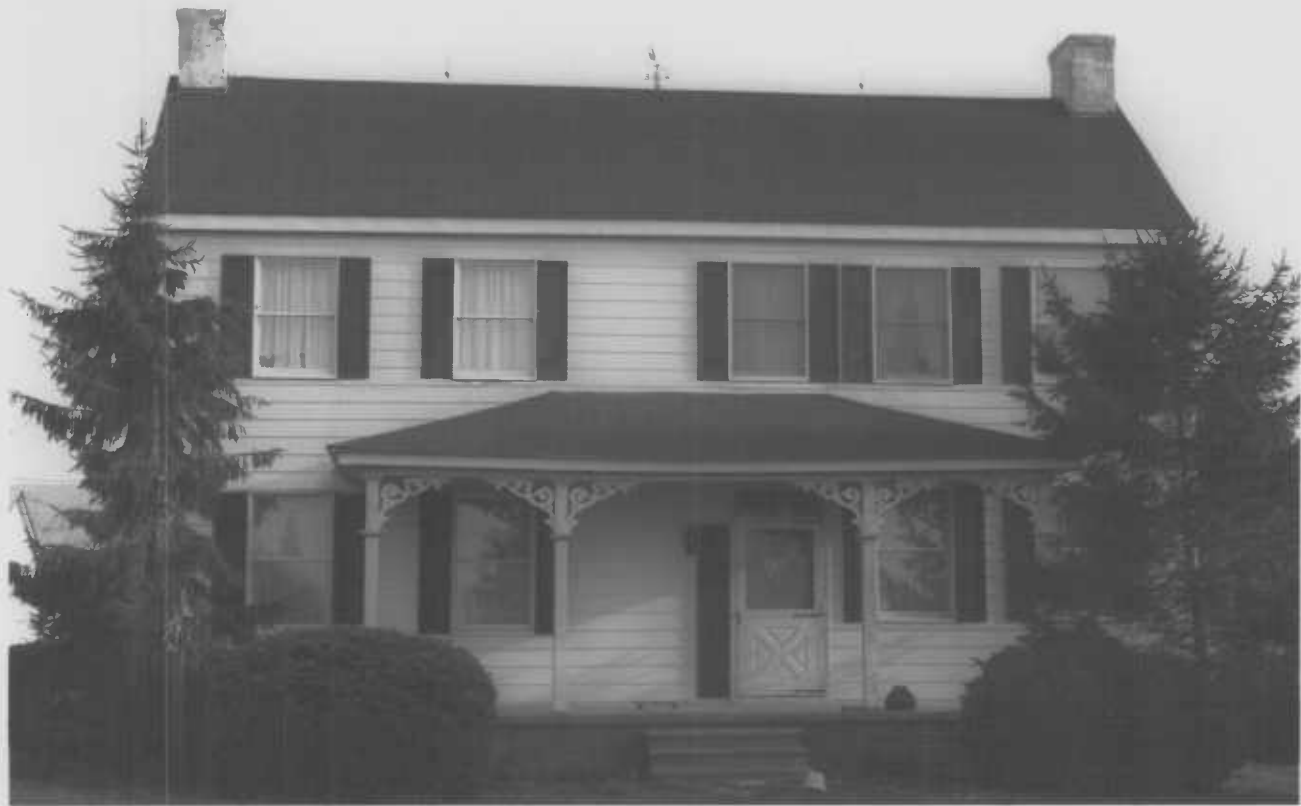
1C617-32

K-617

Hem-Mar Farm

Rt. 291, near Chesterville

M. Q. Fallaw - 5/6/86

View to south

A handsome three-bay wide hipped-roof porch was added across both facade sections in the late nineteenth century. The bays are not equal; the center one is larger. There are handsome, pierced sawn brackets on each side of the posts. The steps and porch floor are now concrete.
